North Central Waterwatch  
River Health Snapshot Report

## **Bendigo Creek Citizen Science Project**

1 July 2018 to 30 Dec 2019

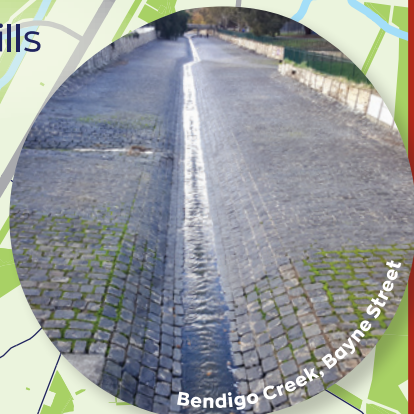
Bendigo Creek, Bayne Street

This site is immediately downstream of the CBD and readings are the poorest of all sites monitored. The site is characterised by a concrete channel and bench and is heavily impacted by the vast stormwater inputs from the city and surrounding industries. Turbidity, phosphorous and electrical conductivity area all rated as poor.

Immediately downstream of the site, Back Creek joins the Bendigo Creek, behind the Bendigo Tennis Complex. Back Creek is a major tributary to the Bendigo Creek. Historical records indicate the site was "...the loveliest spot on Earth, with waterholes with water in them as clear as crystal, kingfisher birds flitting about in the silver wattle, whose lovely foliage almost hid the banks of the creek from view, with occasional splashings as the duck-billed platypus..."
