North Central Waterwatch
River Health Snapshot Report
**RiverScan Citizen Science
Project 2019**

Little Murray River

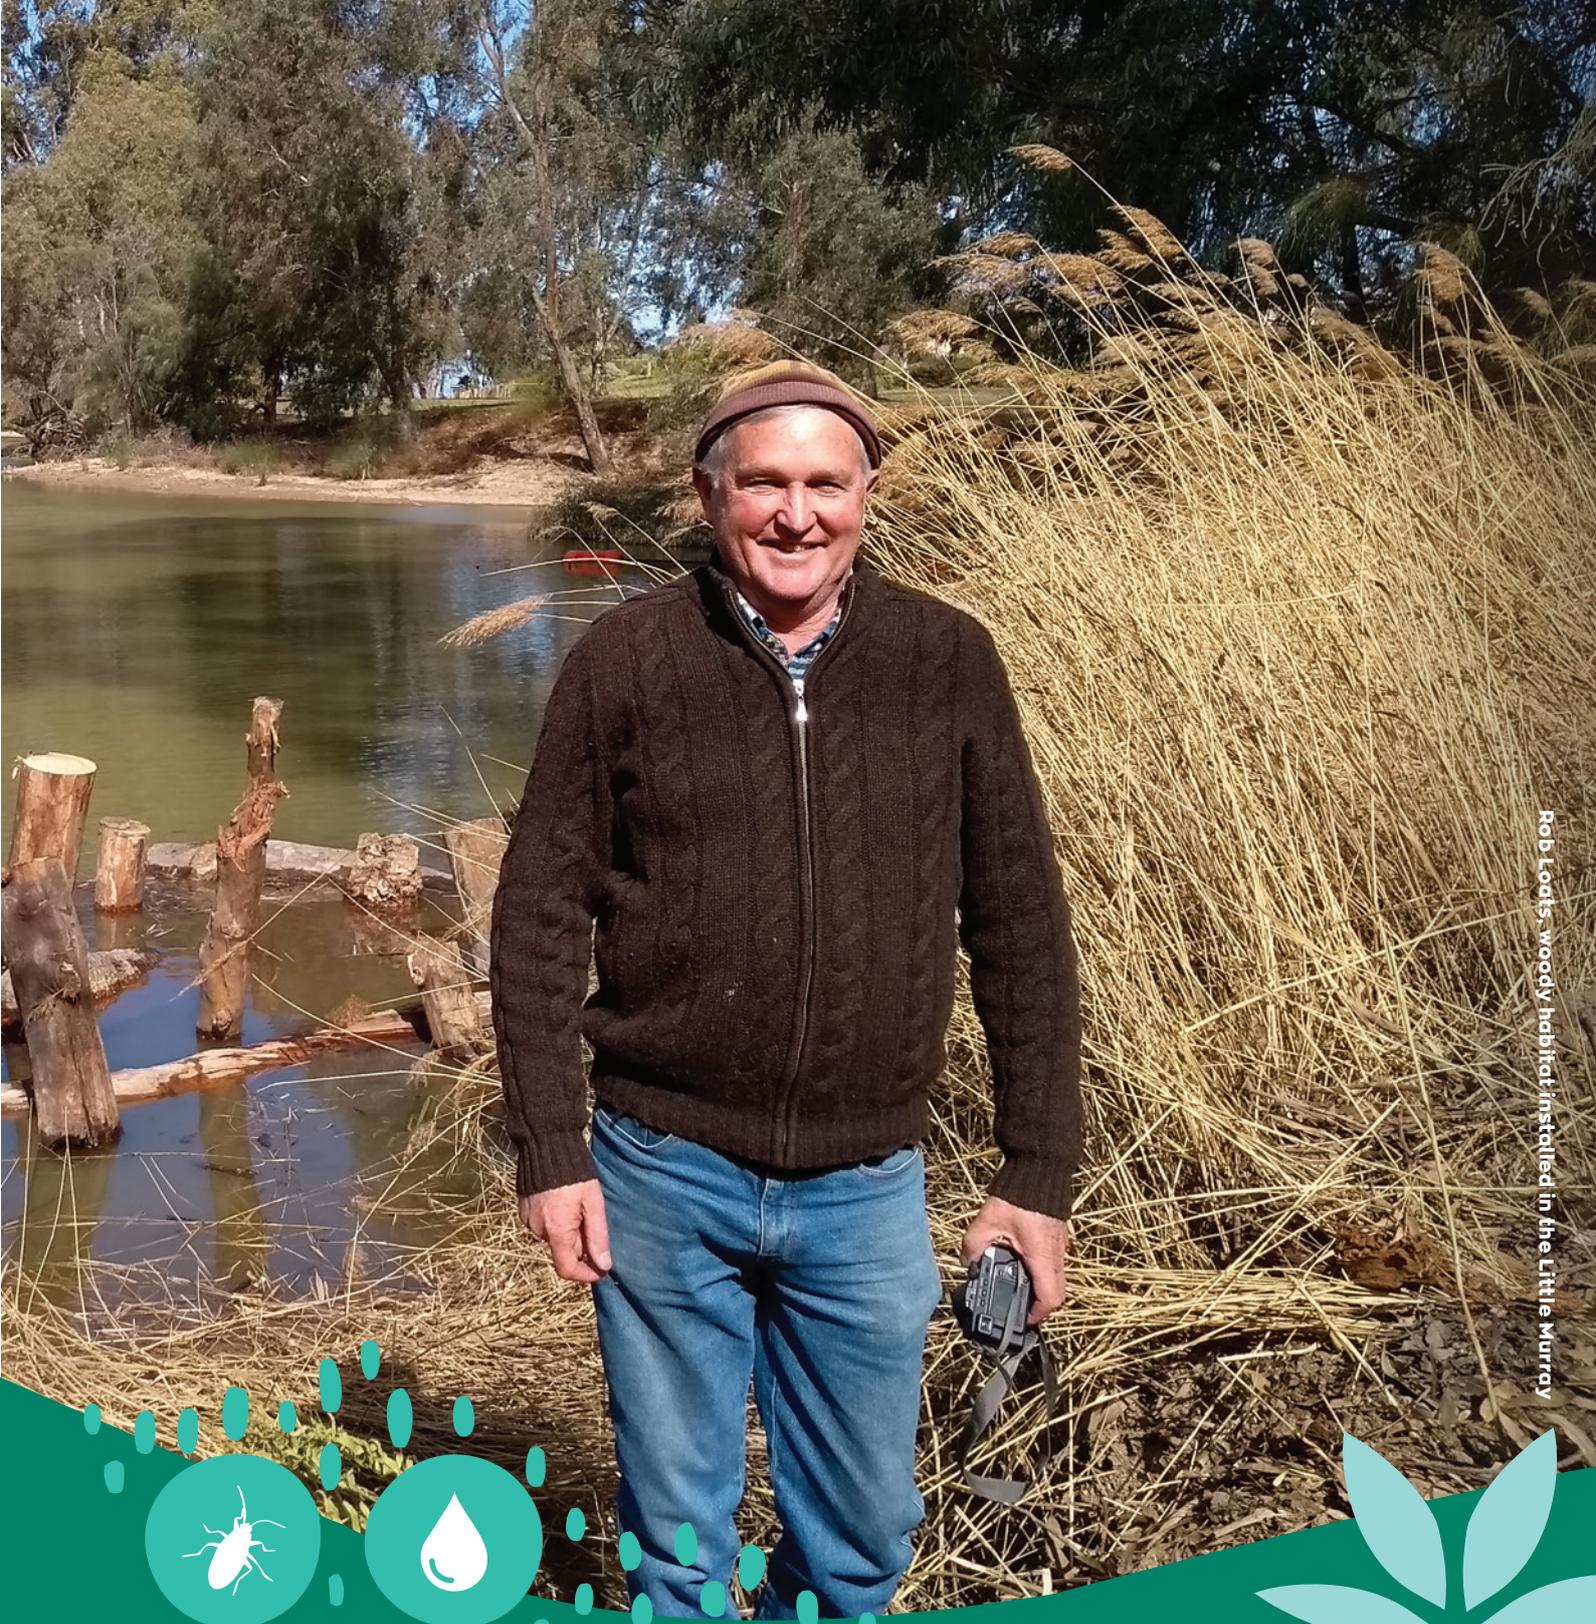
Rob Loois, woody habitat installed in the Little Murray

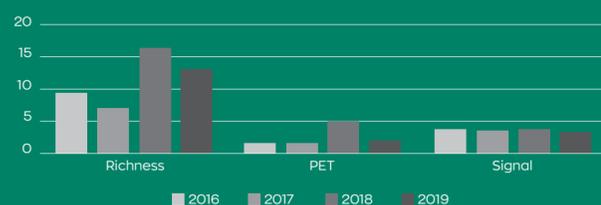
Little Murray Waterbugs

Although there has been a minor decline in ecological health for Little Murray River in macroinvertebrate data meeting ALT objectives from 2018 to 2019, there has still been a significant improvement in ecological health since 2016. Two of the three indices show that Little Murray River is in moderate health. This includes richness and signal. Of the three sites monitored at Little Murray River, Herbie Lane has shown to be in moderate-good ecological health. The richness at Herbie Lane was the highest of all the sites monitored, and the PET and signal scores showed that the objectives were nearly reached. The sites monitored off Petal Island Road showed moderate health, however, the site off Little Murray Weir is depicted to be in poor ecological condition. In contrast, the water quality sampling shows that all three sites have high water quality for all four indices.

Waterbug Taxa Richness	ALT EPT	Signal Score	EC (Us/cm)	pH	Turbidity (NTU)	Phos (Mg/L)
13	2	3.3	134	8.22	37	0.003

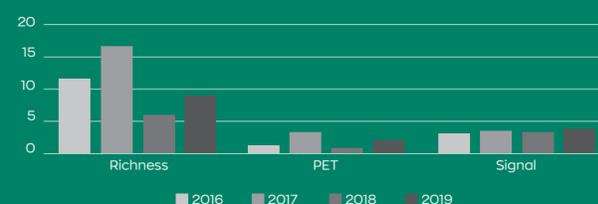
Box-Pyramid Creek Waterbugs

Box-Pyramid Creek has the second most sample sites, and the largest disparity of results between sites. The richness ranges between 5-10, the PET scores range from 0-3 and the signal scores range from 3.2 to 4.8. However, overall the Box-Pyramid Creek has shown an improvement in two of the three indices since 2016. The highest water quality results were recorded in 2017 for all three indices. Both the McKenzie road and the Dobson road site had excellent signal scores. The other sites had moderate signal scores, except for the Kow Swamp site, which had a poor signal score. The overall results suggest that Box-Pyramid Creek is in poor-moderate condition.

Waterbug Taxa Richness	ALT EPT	Signal Score
9	2	3.8

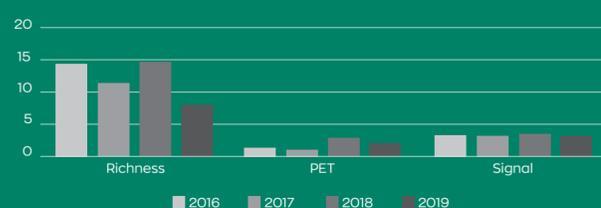
Loddon River Waterbugs

Overall, the results from the 2019 monitoring suggest that the Loddon River is in poor-moderate health. In 2019, there were eight monitoring sites along the Loddon River where macroinvertebrate data was collected. Since 2016, there has been a minor decline in richness, however, signal score has remained relatively constant and PET scores have improved. Major's Line had one of the highest signal scores of all the sites. Furthermore, there were four sites along the Loddon River where water quality data was collected. All four sites indicated good EC pH, and phosphate levels. All four sites indicated poor quality turbidity levels. Overall, indicating that the Loddon River is in moderate-good ecological health. Due to the Loddon River being highly modified, it is anticipated that the health of the ecosystems will take a long time to recover.

Waterbug Taxa Richness	ALT EPT	Signal Score	EC (Us/cm)	pH	Turbidity (NTU)	Phos (Mg/L)
8	2	3.2	410	7.66	161	0.055

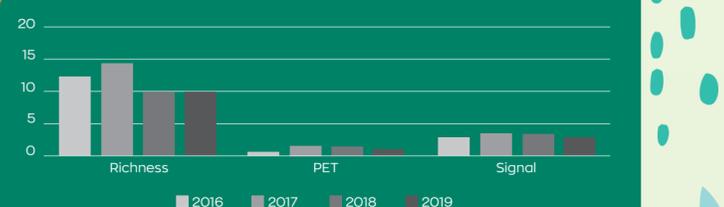
Gunbower Creek Waterbugs

The overall results from the 2019 Spring sampling suggest that Gunbower Creek is in poor-moderate health. The richness of the five sites varies significantly, between 7-14. The site with the highest richness was the Koondrook/Dry Swamp site. Shelby's Road had the highest PET score, and Darmoyle Road had the highest signal score. Since sampling in 2016, both the PET and signal scores have improved overall. There were no water quality samples taken at any of the Gunbower sites during the 2019 spring monitoring.

Waterbug Taxa Richness	ALT EPT	Signal Score
10	1	2.8
