North Central Waterwatch  
River Health Snapshot Report

## **Bendigo Creek Citizen Science Project**

1 July 2018 to 30 Dec 2019

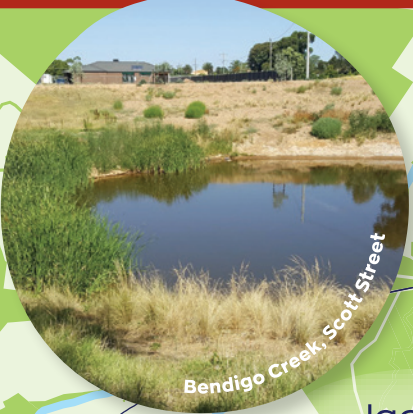
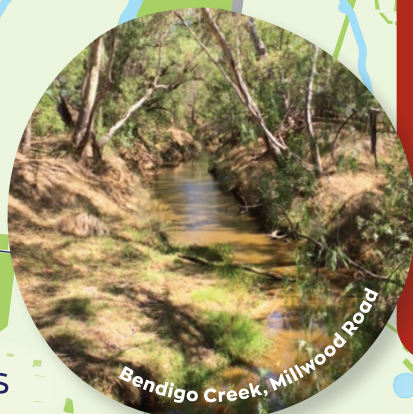
Bendigo Creek, Millwood Road

Site Code: BGO060 Monitor: Nicole Howie

Phosphorous levels return to a moderate level and turbidity begins to drop out. Good pH continues, while turbidity, phosphorous and electrical conductivity are rated as moderate.
